Handshakes and headaches

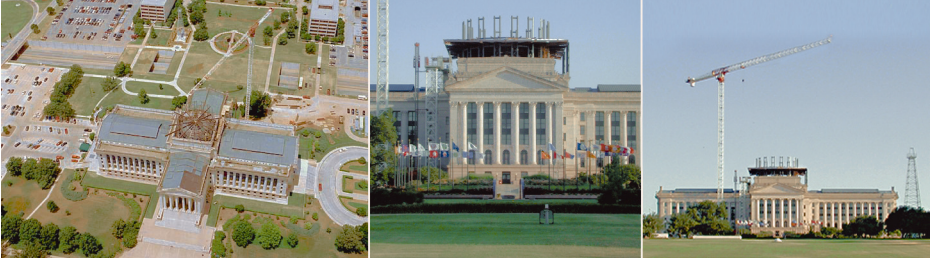
Early construction of the high dome involved the installation of the structural steel with the use of a tower crane 280 feet tall.

That the high dome was a process of constructing, restoring, renovating, and creating, made the project inherently difficult, time-consuming, and expensive. “Nobody’s done a dome in a long time,” as one construction overseer stated. There were difficulties with nature: The Oklahoma wind interfered frequently with the operation of the state’s tallest tower crane (at 280 feet). Some difficulties were logistic, such as those related to keep-

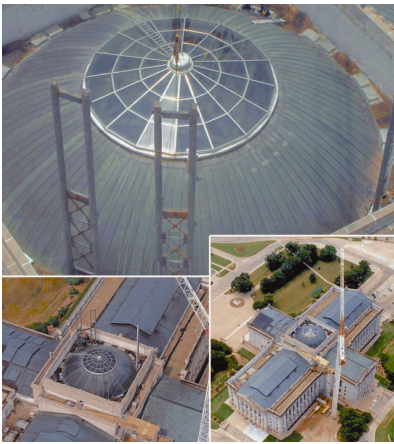
Several shots of the saucer dome before removal (June 2001).

And then there was the weighty matter of the saucer dome removal. A dome builder remarked, “We never got the full grasp of that concrete saucer dome until we dismantled everything in there, took out the skylight and took the state seal

down. When we finally exposed all of this concrete structure up in there, we could not believe it!” The saucer dome removal, all 2 million pounds of brick and concrete, came out with a jackhammer and thousands of wheelbarrow-loads. The task took four months.

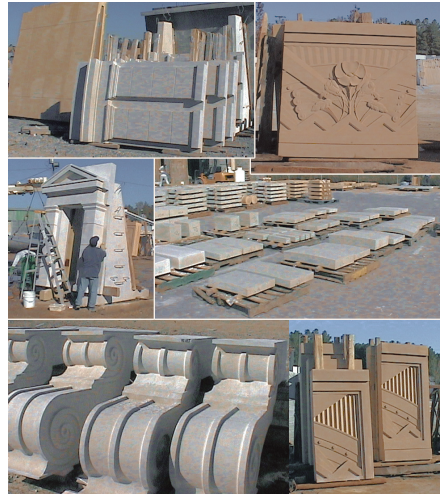
Pre-cast concrete sections comprise the exterior of the dome, ranging in size and weight from a briefcase to a small car.

The pre-cast concrete sections that comprise the exterior of the dome were made by trial and error. Simply, it is very difficult to find a company that makes pieces this size. Or shape. Several attempts were required simply to get the mold right. The dome is clad with hundreds of pre-cast pieces, ranging
